RESEARCH MEMORANDUM

LATERAL AND DIRECTIONAL STABILITY AND CONTROL
CHARACTERISTICS OF A C-54D AIRPLANE

Donald B. Talmage and John P. Reeder

March 24, 1949

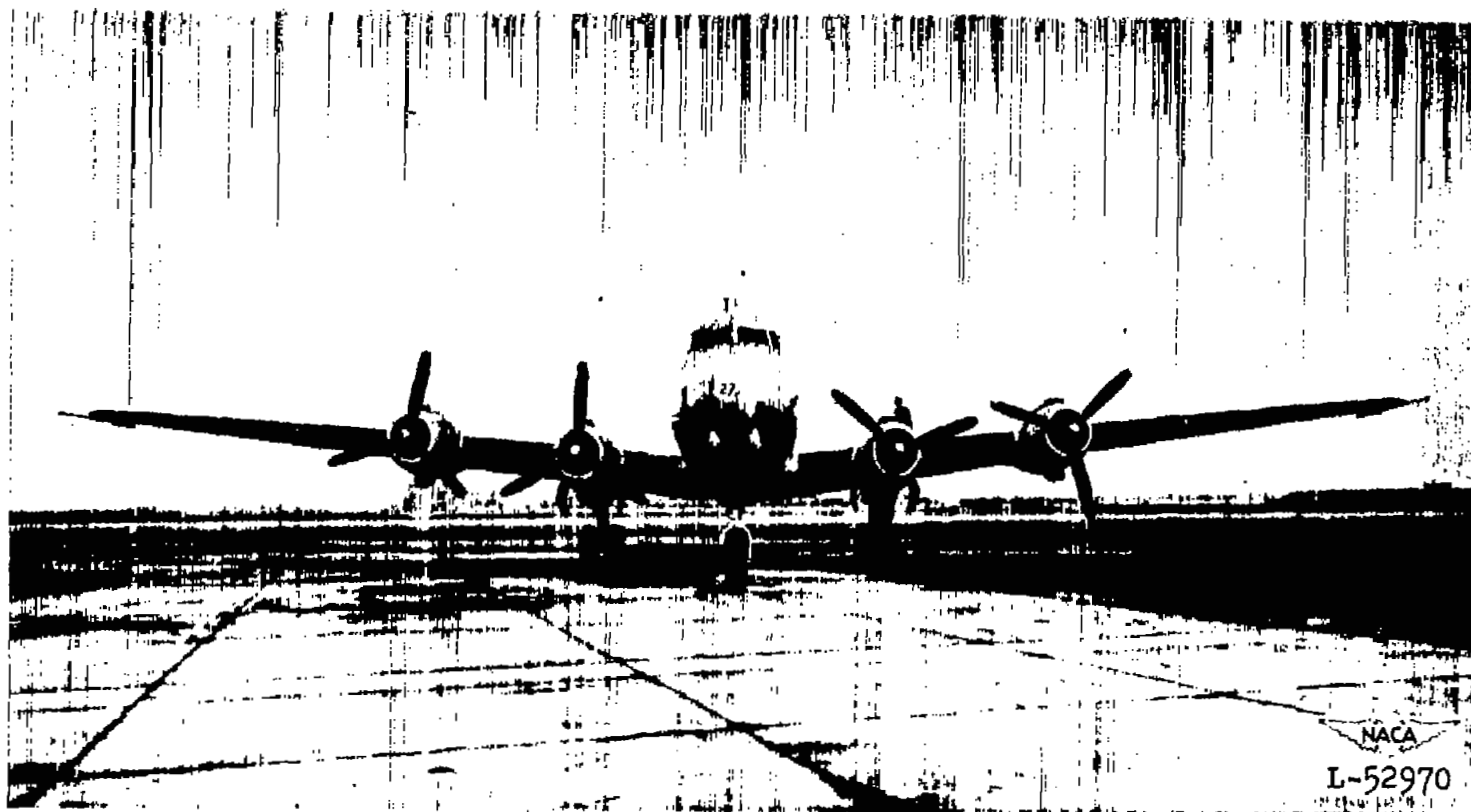
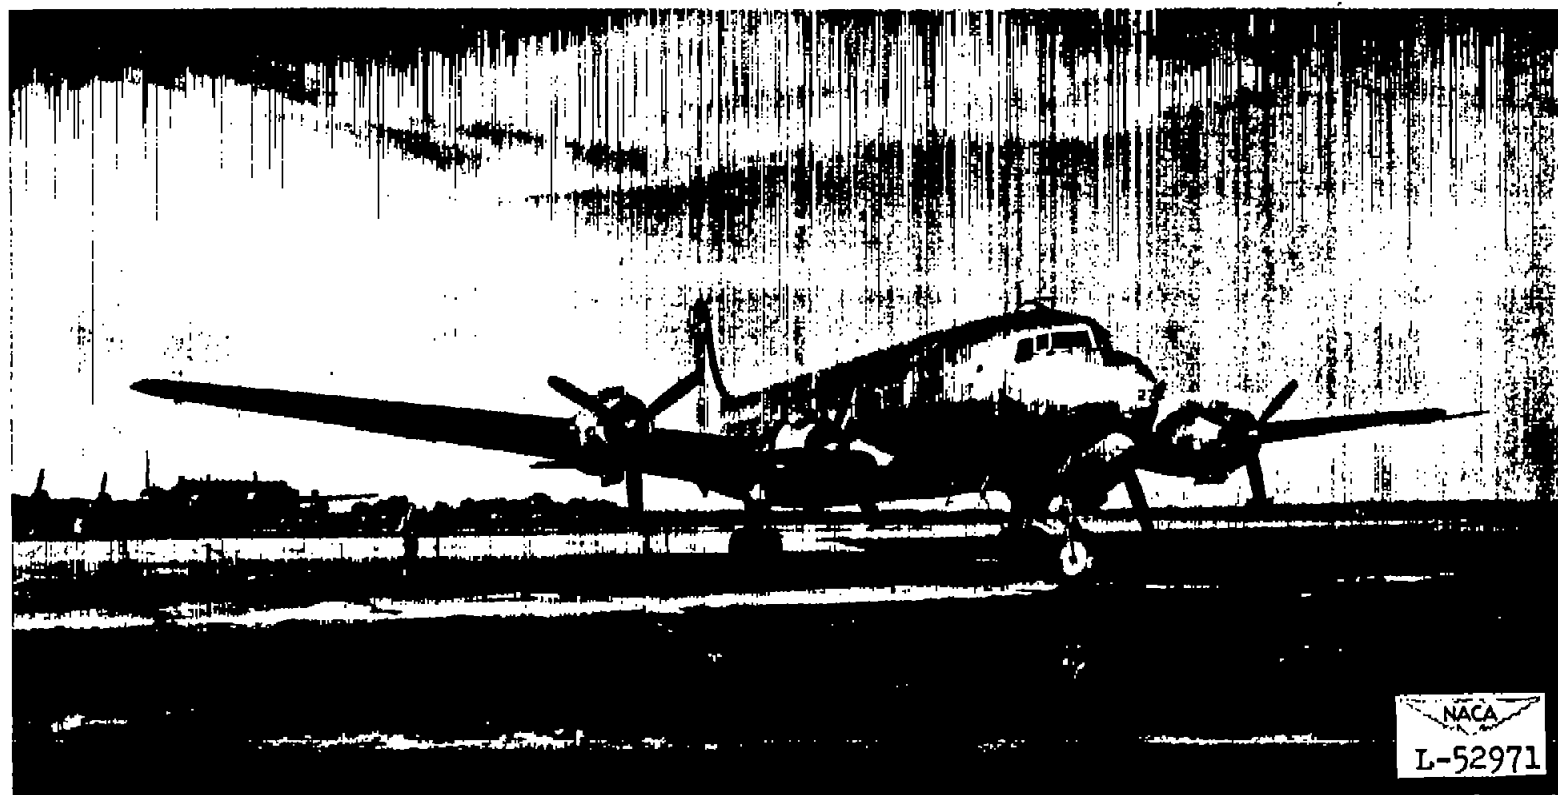
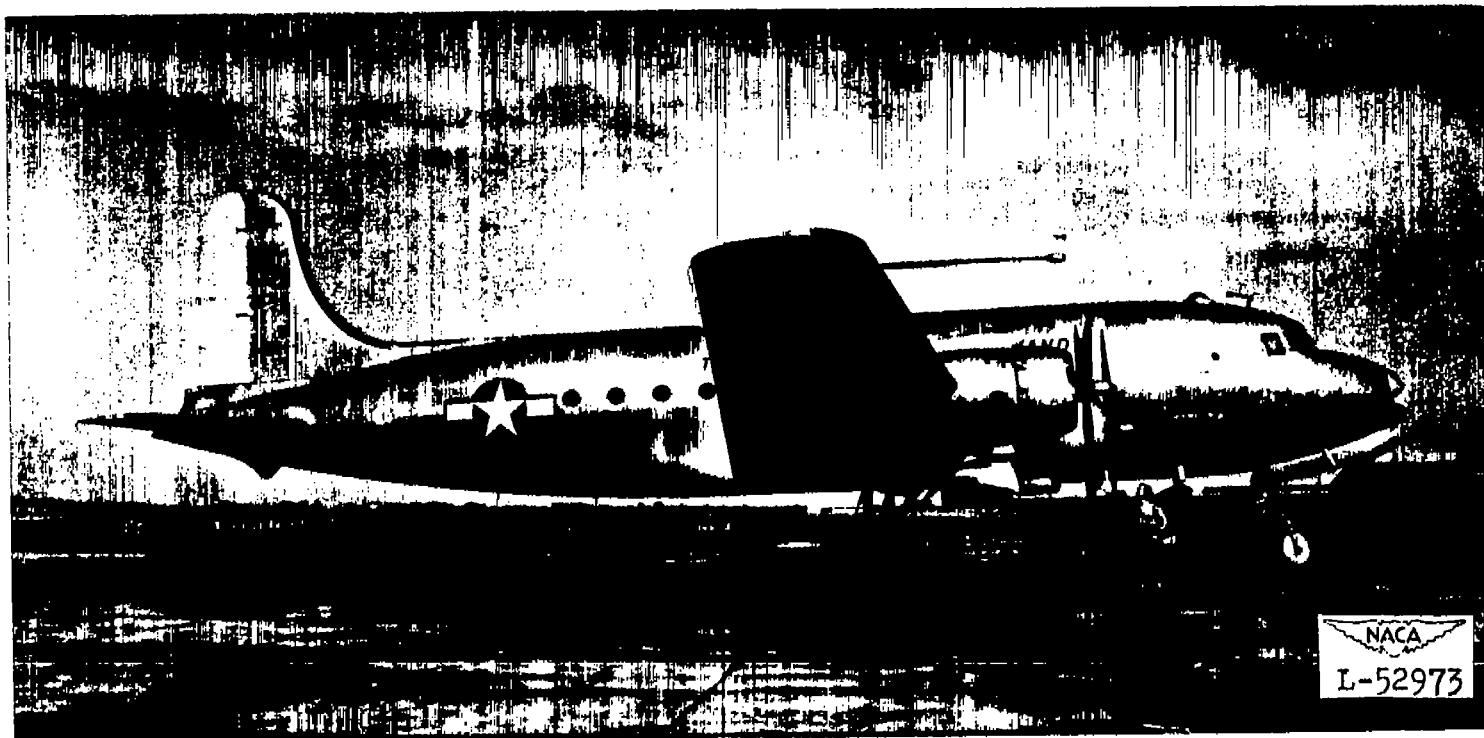
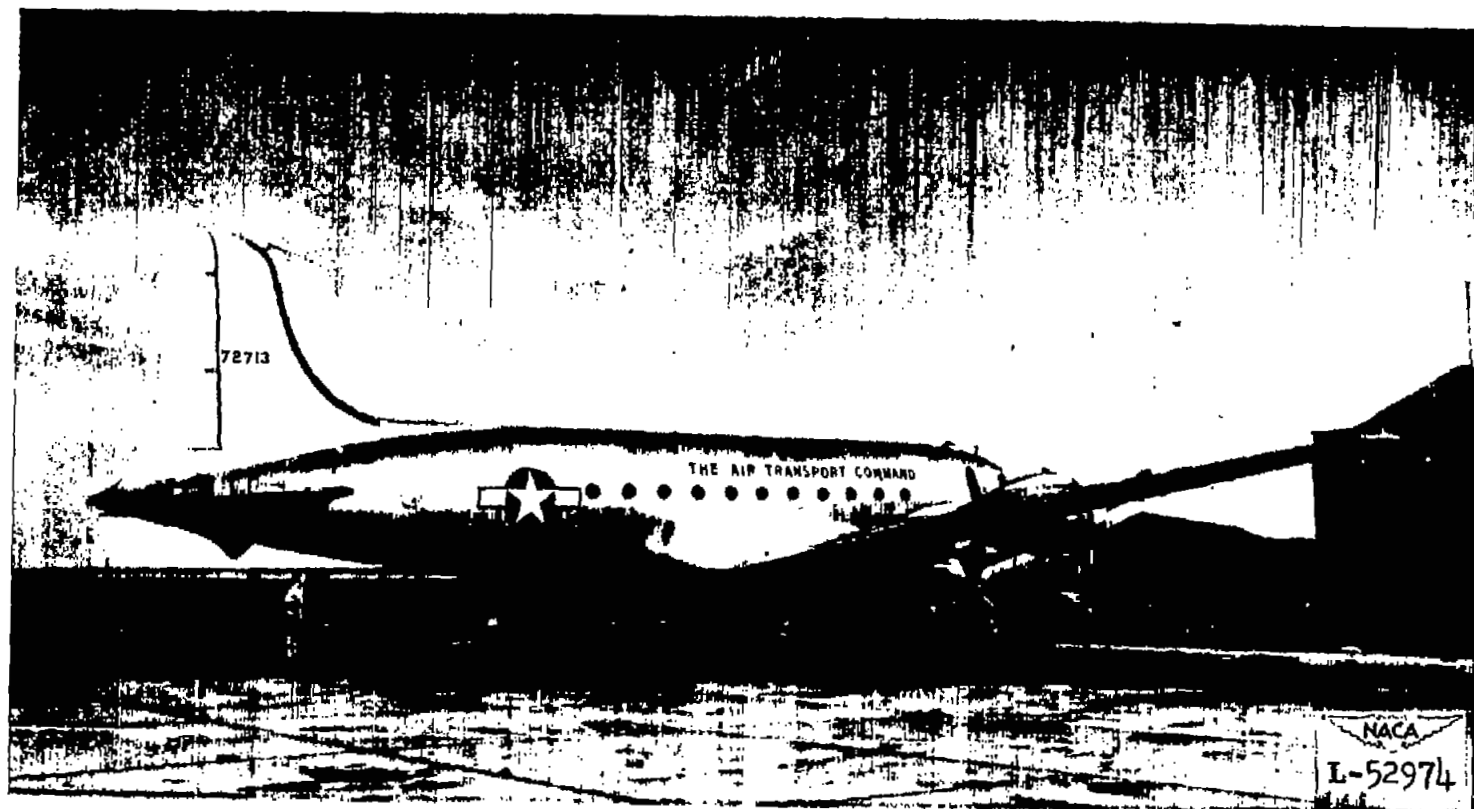
Figure 1.- Photographs of the C-54D airplane on which the tests were conducted.

The C-54D tested was a four-engine, low-wing monoplane with retractable tricycle landing gear, steerable nose wheel, and single slotted flaps. The control surfaces were fabric covered and the remainder of the airplane was metal covered. The elevator and the rudder had plain, round-nose overhanging balance and the ailerons had Frise type balance. The right aileron and the elevators had trim tabs and the rudder had a combination spring and trim tab. The tests were made at a take-off weight of approximately 54,000 pounds and a center-of-gravity position of about 17 percent mean aerodynamic chord with wheels up. General specifications for the airplane are given in table I.

Several photographs of the test airplane are shown as figure 1. The variations of the pilot's control position with control-surface angle for the elevator, aileron, and rudder are shown in figure 2. The characteristics of the rudder spring tab (or flying tab) are presented in figure 3; the ratio between rudder-pedal position and tab position with the rudder fixed could not be measured accurately because of stretch in the control system. It was estimated, however, that the pedal moved 0.02 inch per degree movement of the tab. The investigation was conducted with the automatic-pilot servo-units installed. In this condition, the friction in the control systems was ± 15 pounds for the elevator, ± 12 pounds for the ailerons, and ± 30 pounds for the rudder as measured in flight. The servo-units were responsible for about ± 10 pounds friction in each control system. The effects of this friction are discussed in references 1 and 2.

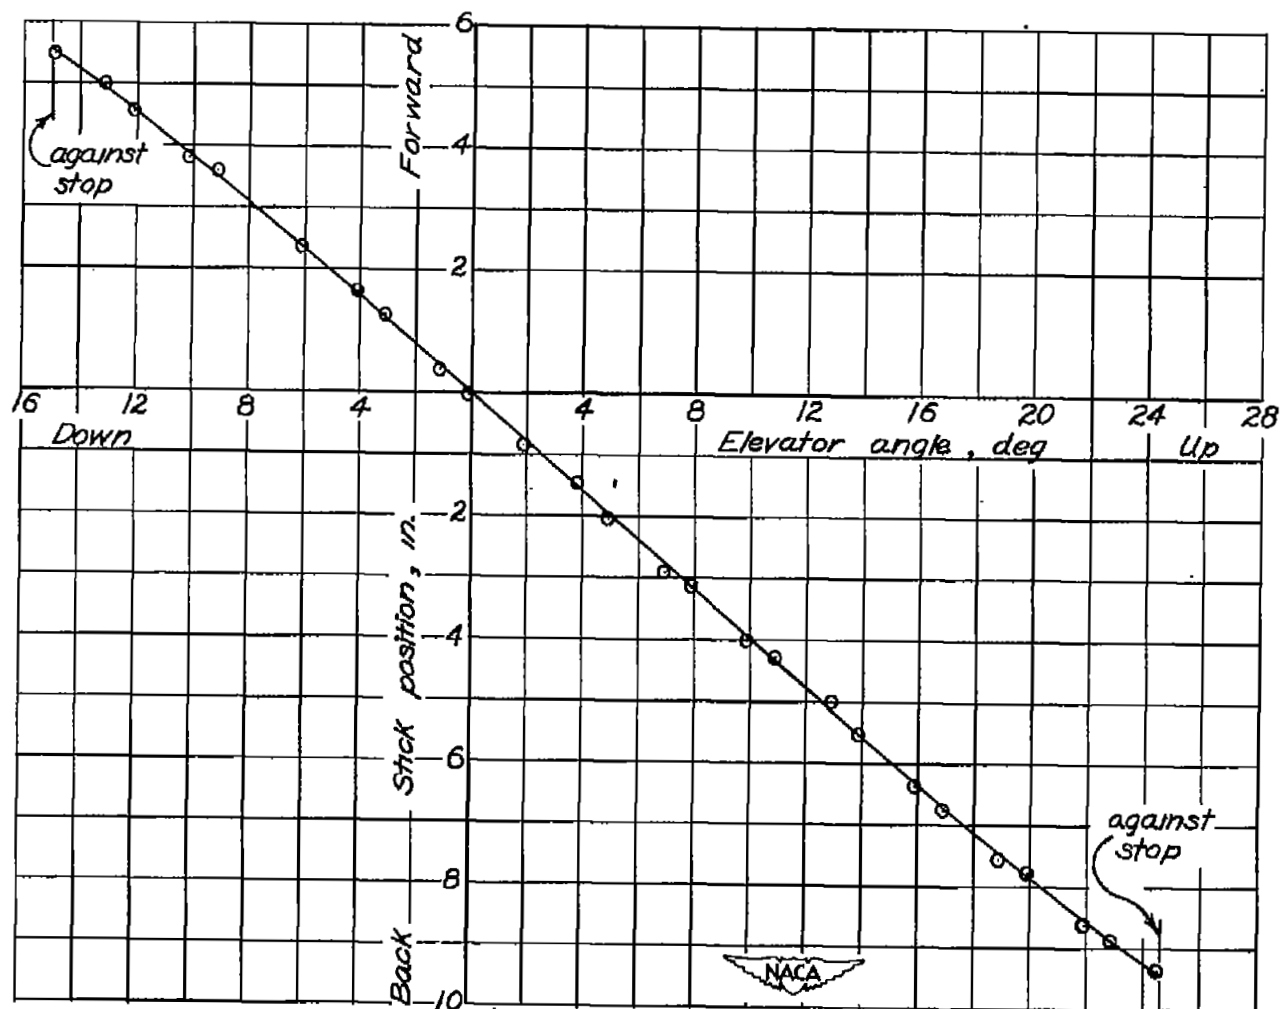
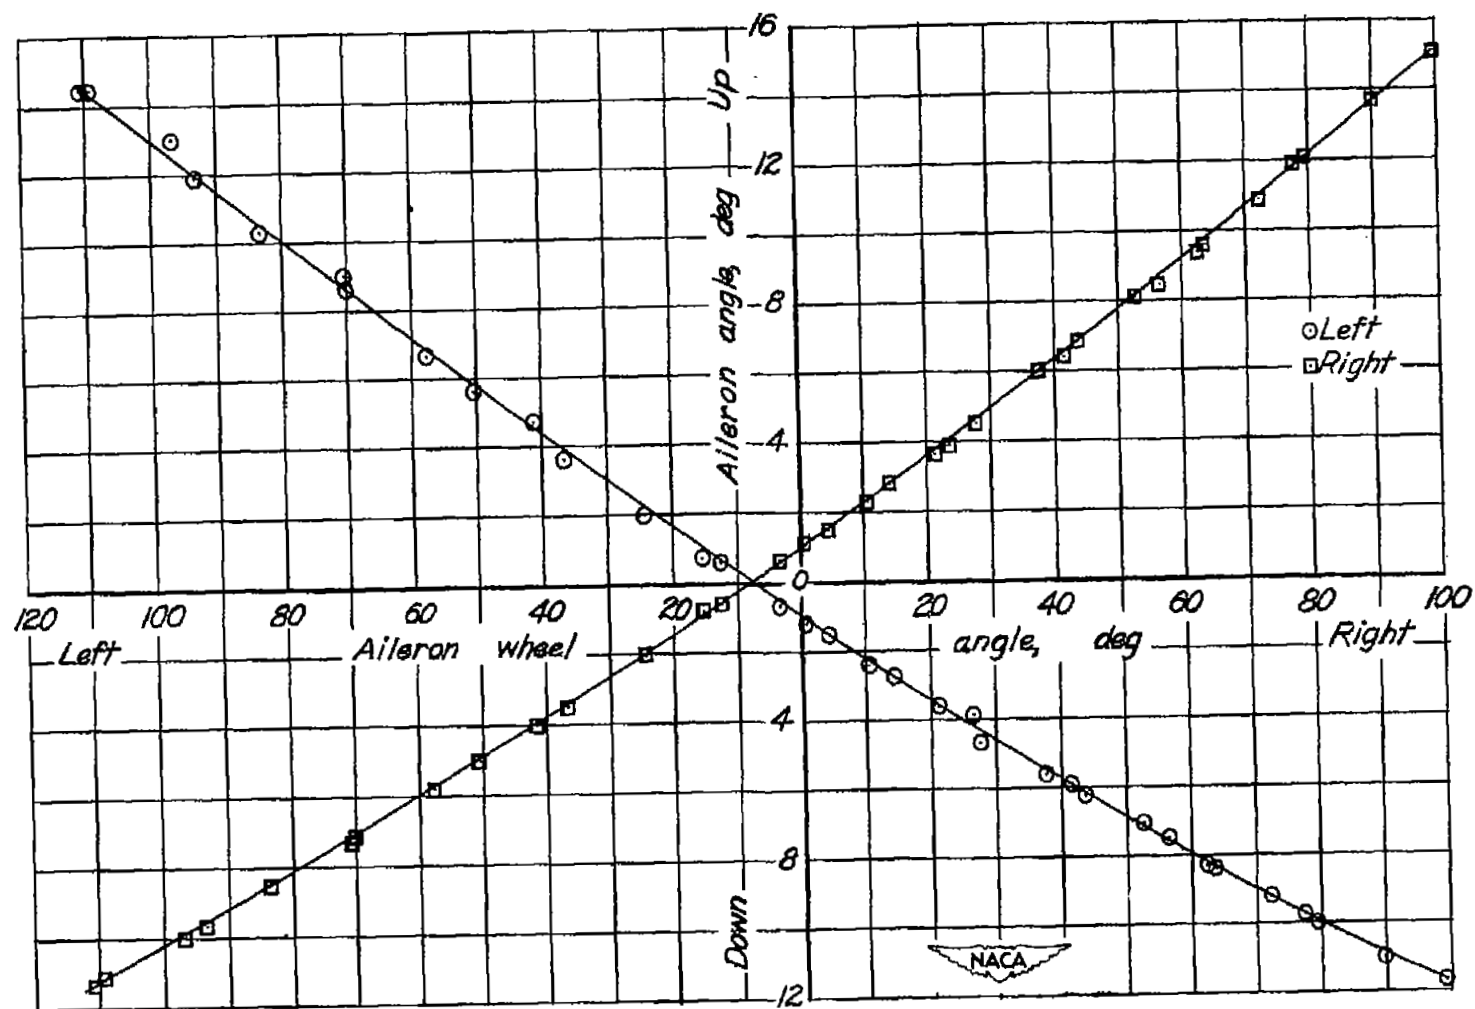
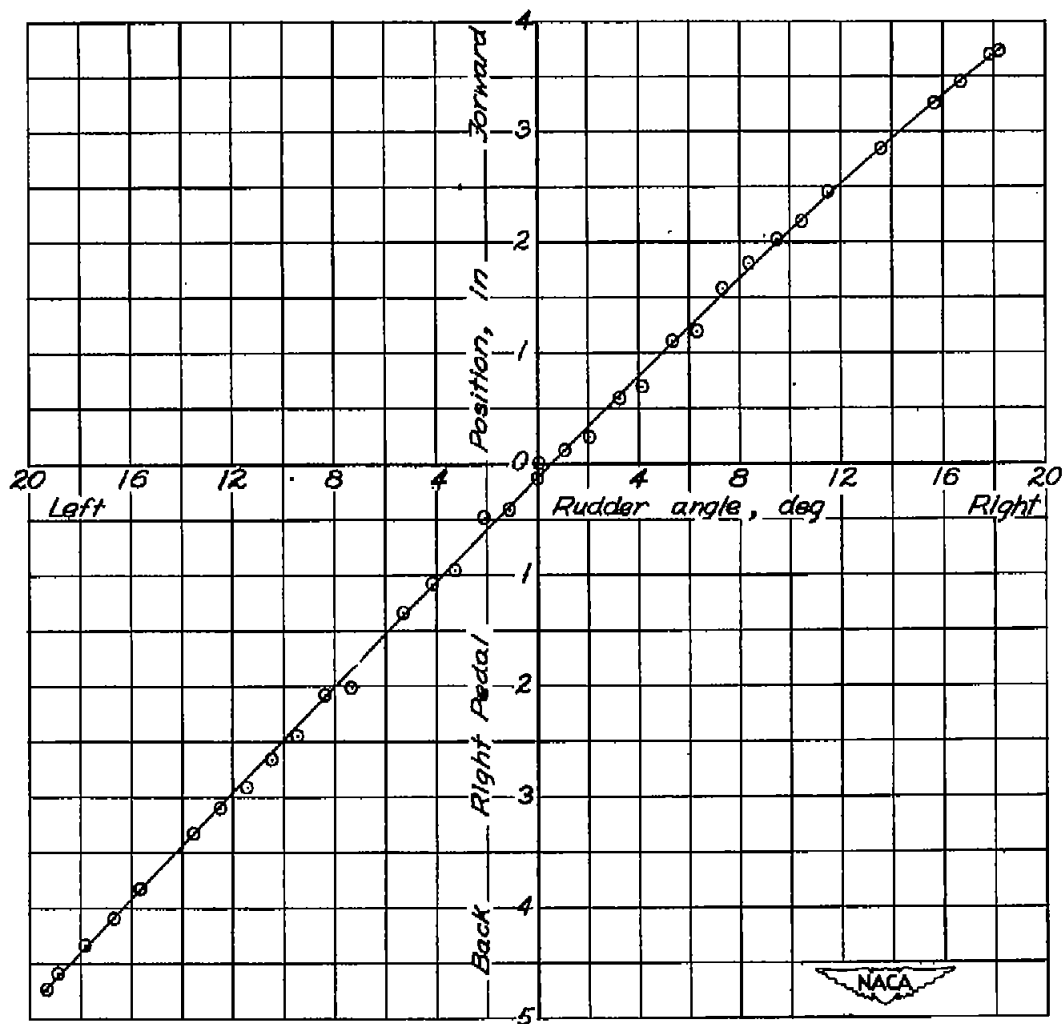
(a) Elevator control.

Figure 2.— Control linkage with no load. C-54D airplane.

(b) Aileron control.

(c) Rudder control.

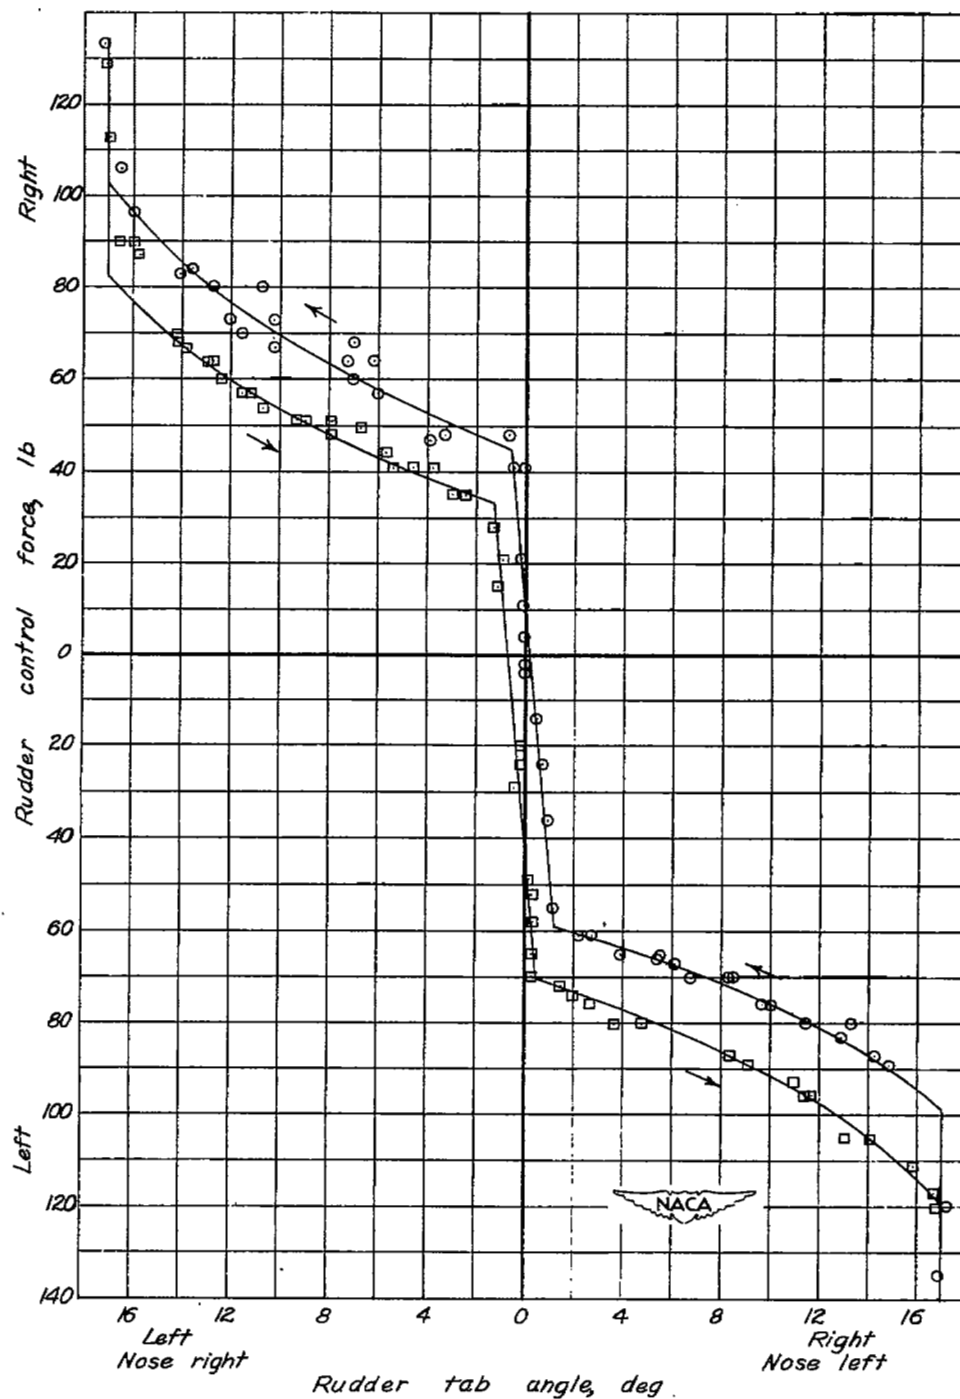
Figure 3.- Characteristics of the rudder spring tab with no load on the tab. C-54D airplane. Rudder fixed at neutral.

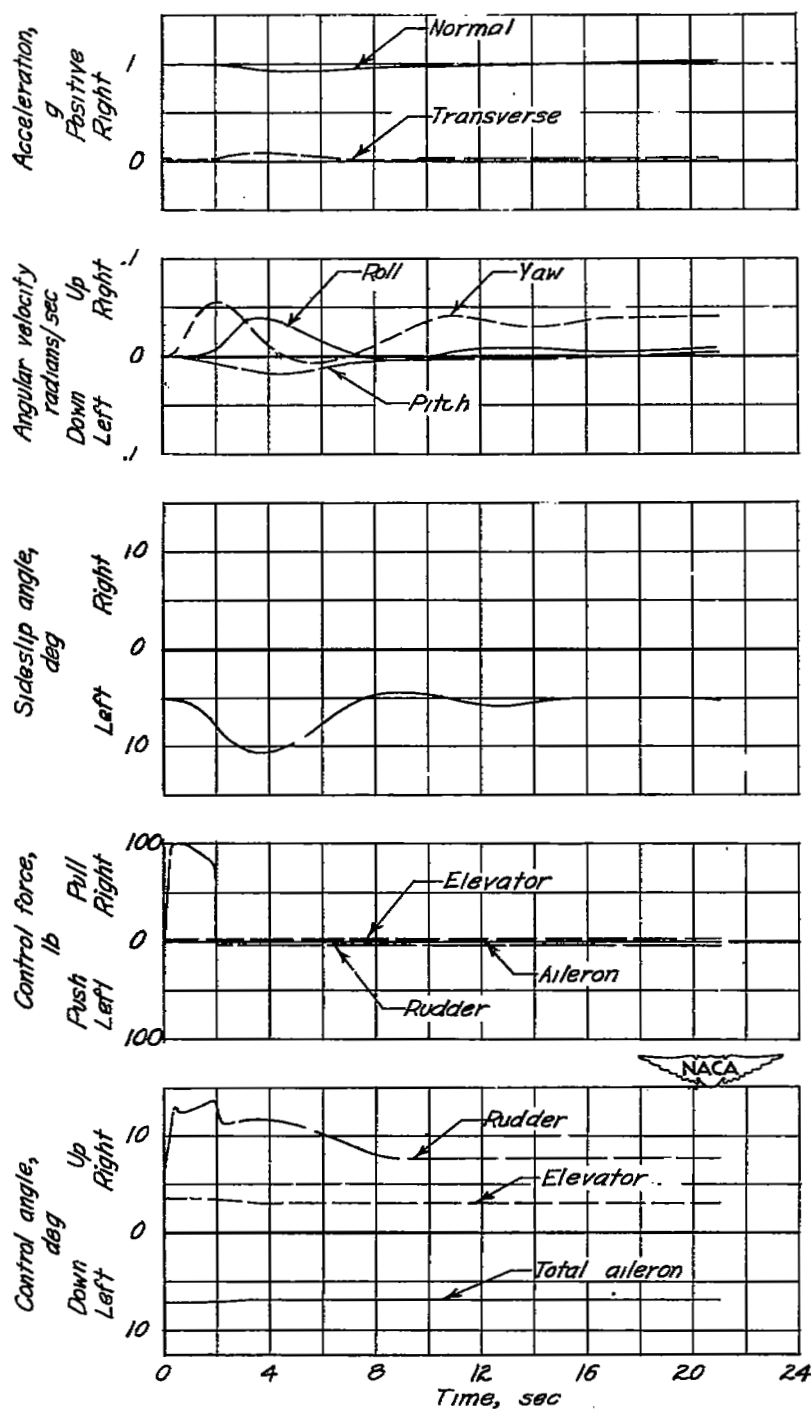
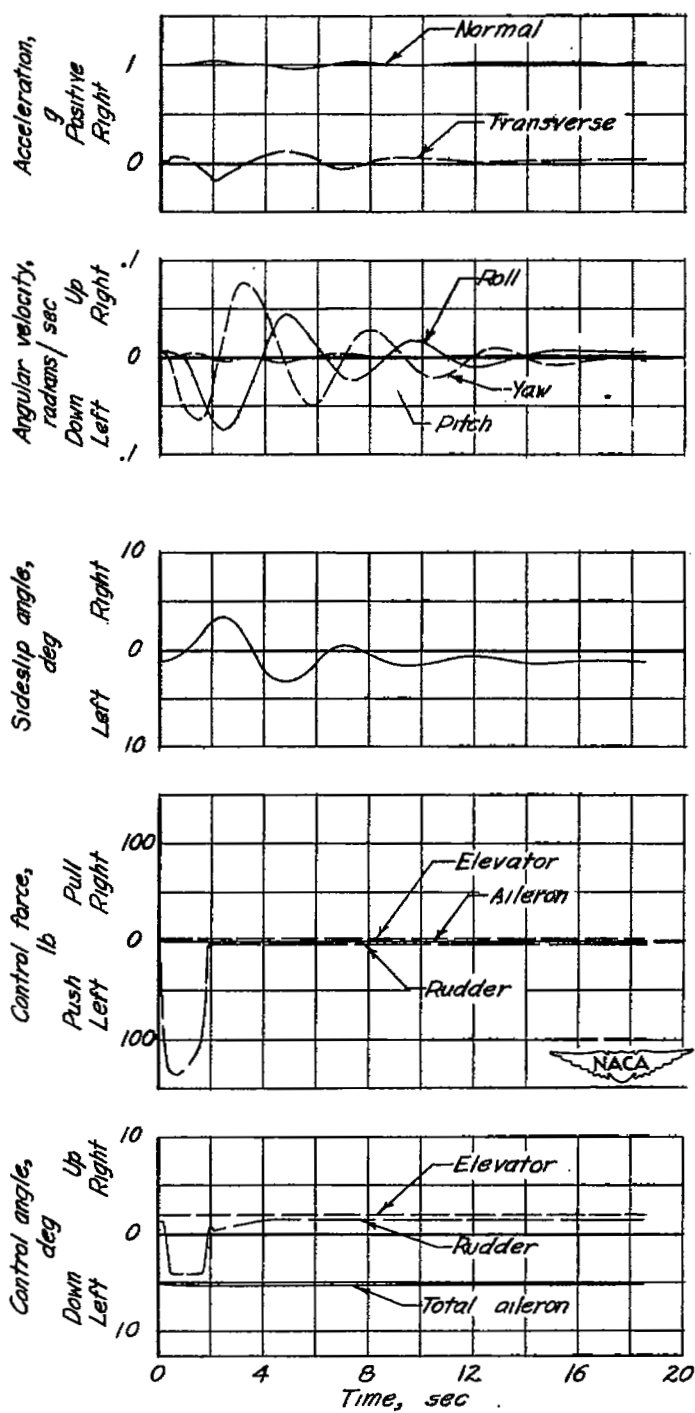
Figure 4.— Time history of a rudder kick and release. Airplane condition, clean; normal rated power; C-54D airplane.

The lateral and directional short-period oscillations were investigated by abruptly deflecting and releasing the rudder and the ailerons separately while leaving the other controls free at several different speeds. Figure 4 shows time histories of typical rudder kicks and releases at a low speed and at a high speed and figure 5 shows similar time histories for the ailerons. The rudder did not return immediately to trim but came back gradually; however, it did not oscillate. The slow return of the rudder was due to its tendency to float with the relative wind. The directional oscillation as indicated by the sideslip angle was damped to less than $1/2$ amplitude in one cycle. The ailerons did not return completely to the trim position due to the friction in the control system, but they did not oscillate. The airplane continued to roll slowly due to the displaced aileron.

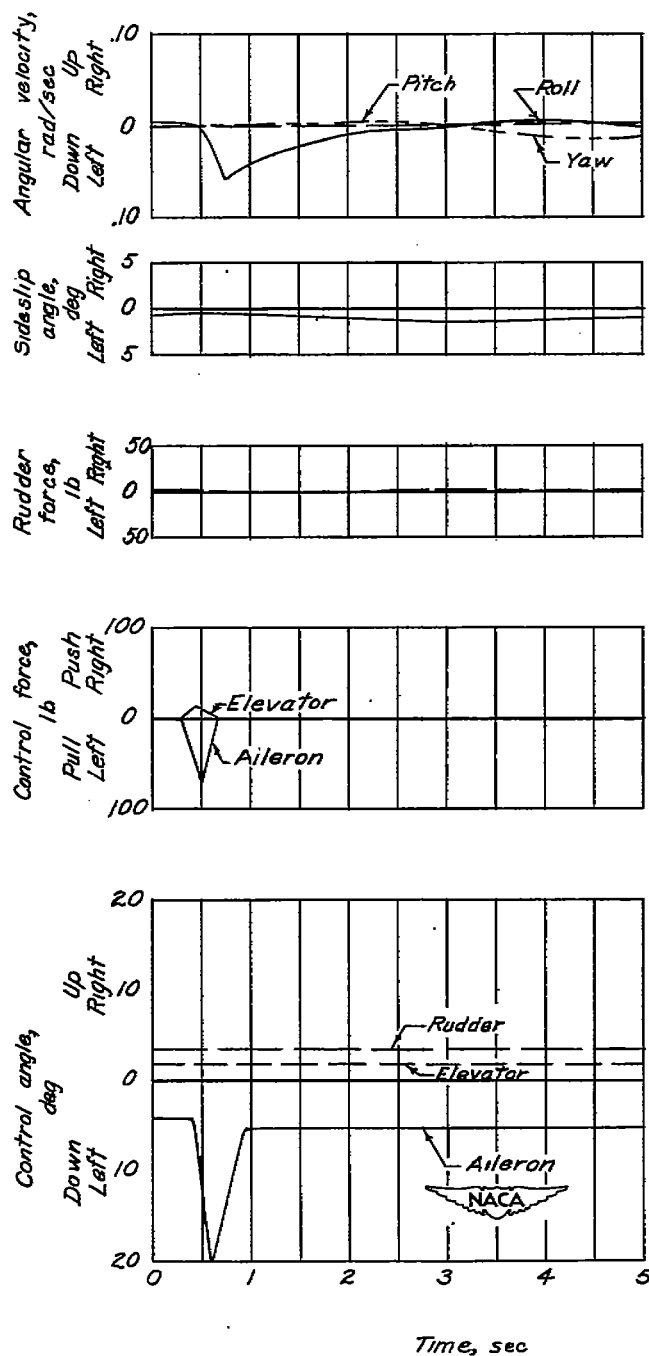
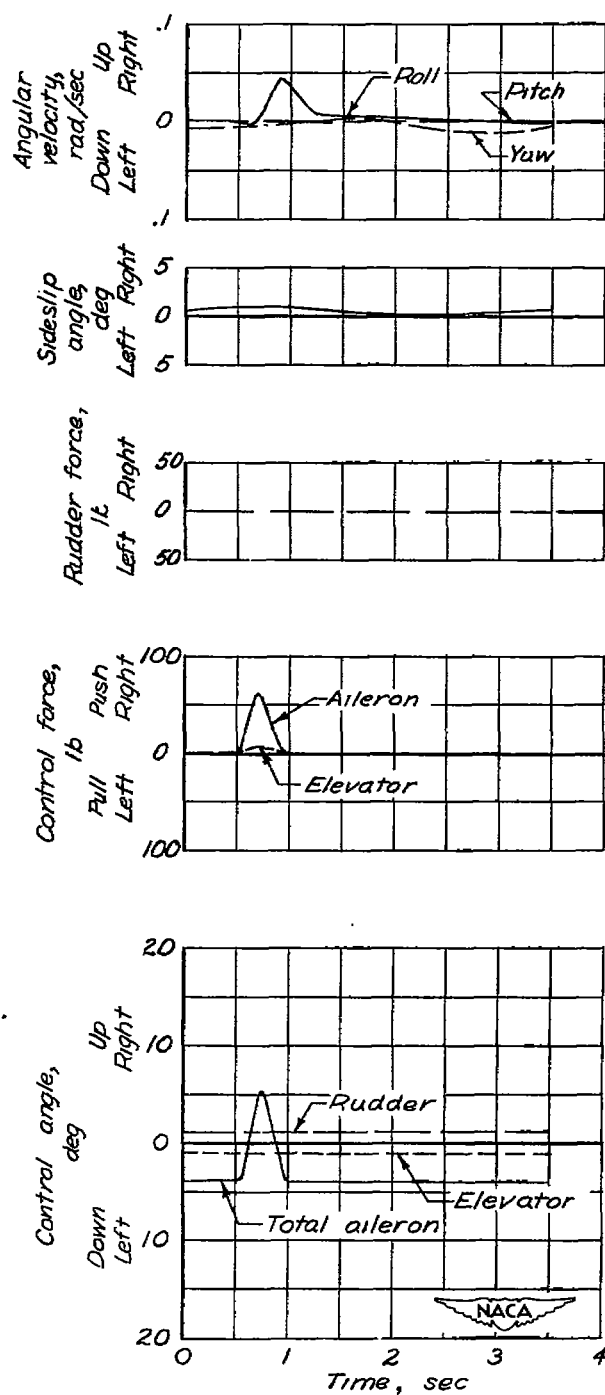
Figure 5.— Time history of an aileron deflection and release. Airplane condition, clean; power for level flight. C-54D airplane.

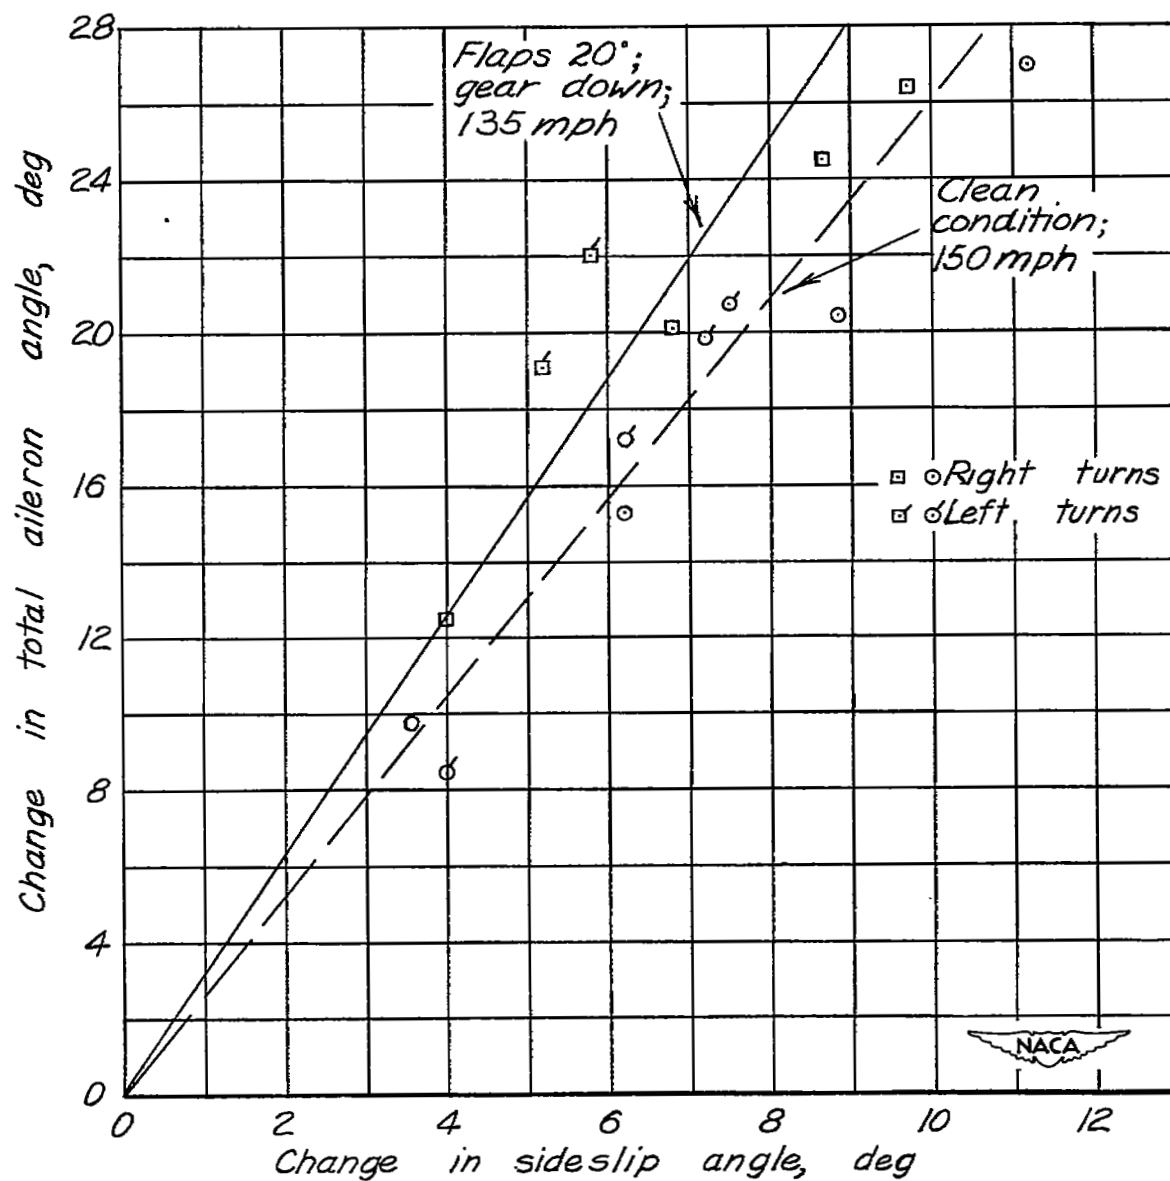
Figure 6.— Variation of the maximum change in sideslip angle with change in aileron angle in rudder locked rolls out of 45° banked turns. C-54D airplane.

The adverse aileron yaw (sideslip due to aileron deflection and rolling velocity) and the amount of rudder to overcome the adverse yaw were measured in rolls out of 45° banked turns in the clean condition at about 150 miles per hour and the approach condition (flaps 20° , gear down) at approximately 135 miles per hour. The approach condition was used rather than the full-flap, gear-down condition because it duplicated the condition used by the airlines during the approach where most maneuvering is done. The adverse aileron yaw was evaluated for rudder-fixed roll-outs, and figure 6 shows the maximum change in sideslip due to varying amounts of aileron deflection. The maximum sideslip angles attained with full aileron deflection was about 10° in the clean condition and about 8° for the approach condition.

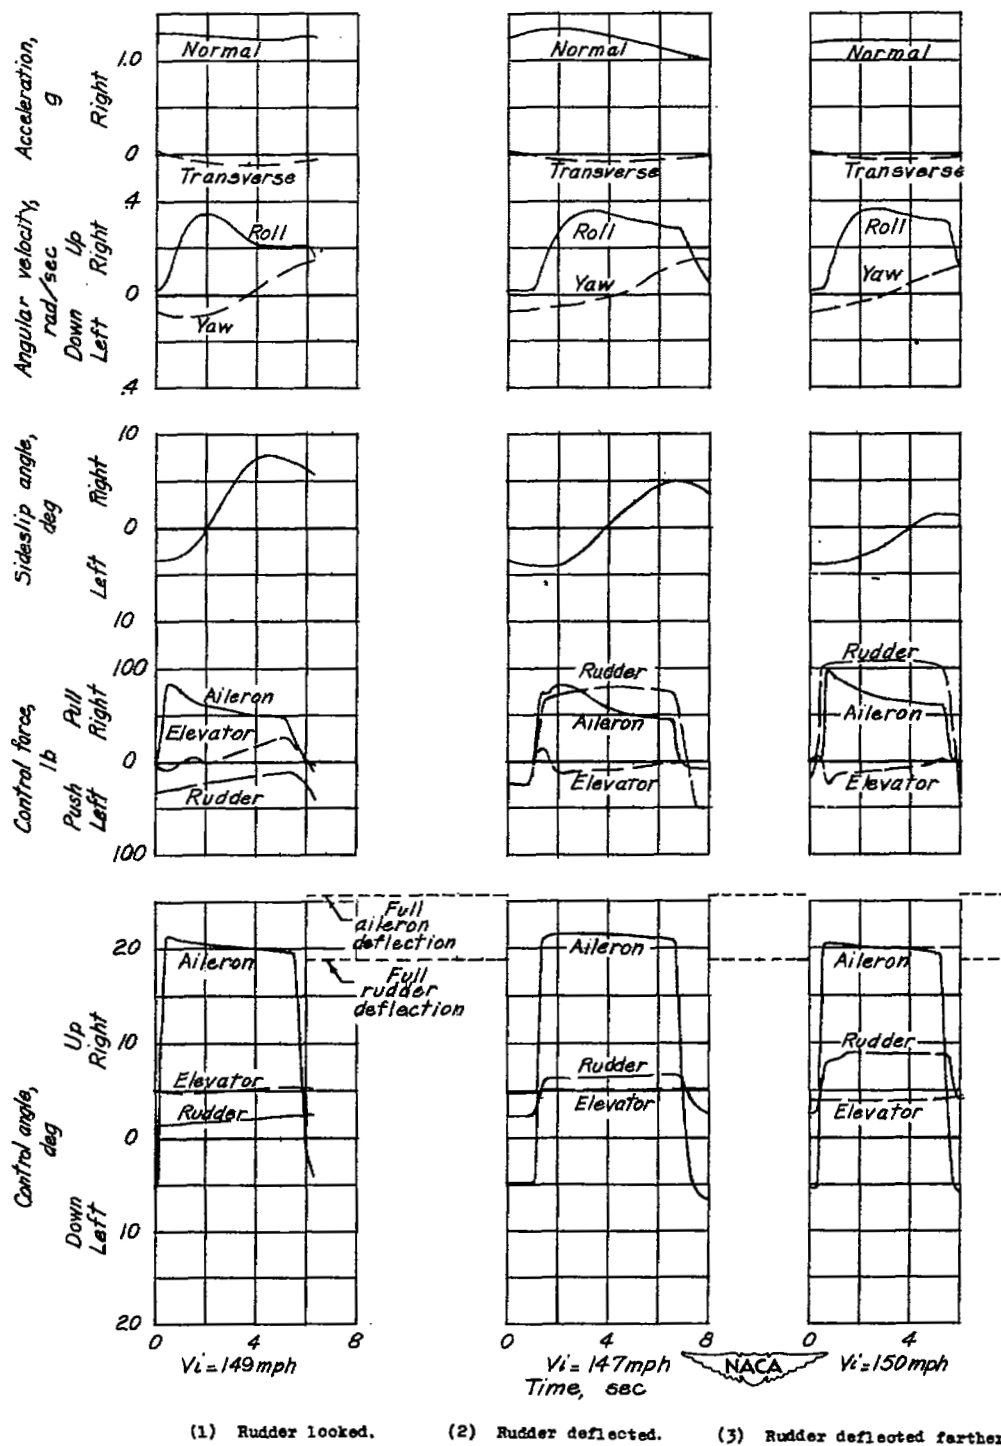
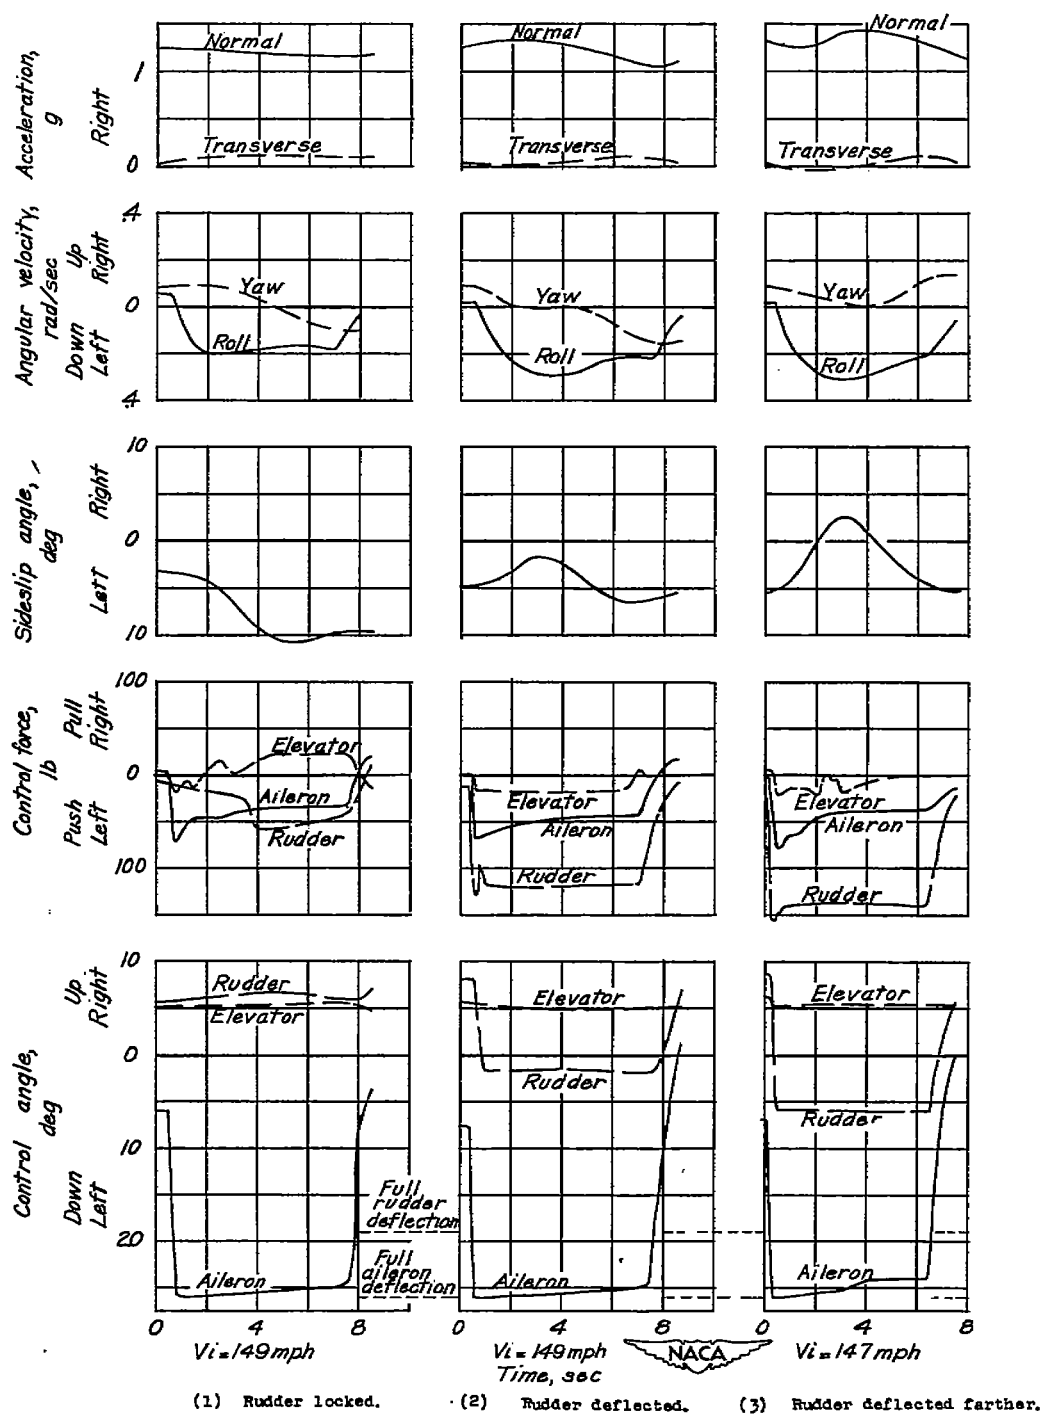
Figure 7.—Time histories of rolls out of 45° banked turns. Clean condition; power for level flight; C-54D airplane.

A measure of the rudder control to overcome the yaw due to the ailerons was obtained by using several amounts of rudder deflection during the rolls out of turns. Time histories of rolls out of turns using varying amounts

of rudder are given in figures 7 and 8. The rudder was sufficiently powerful to produce yawing velocity in the opposite direction without using full rudder deflection. About 100 pounds pedal force was required to offset the aileron yaw and therefore the requirements were met.

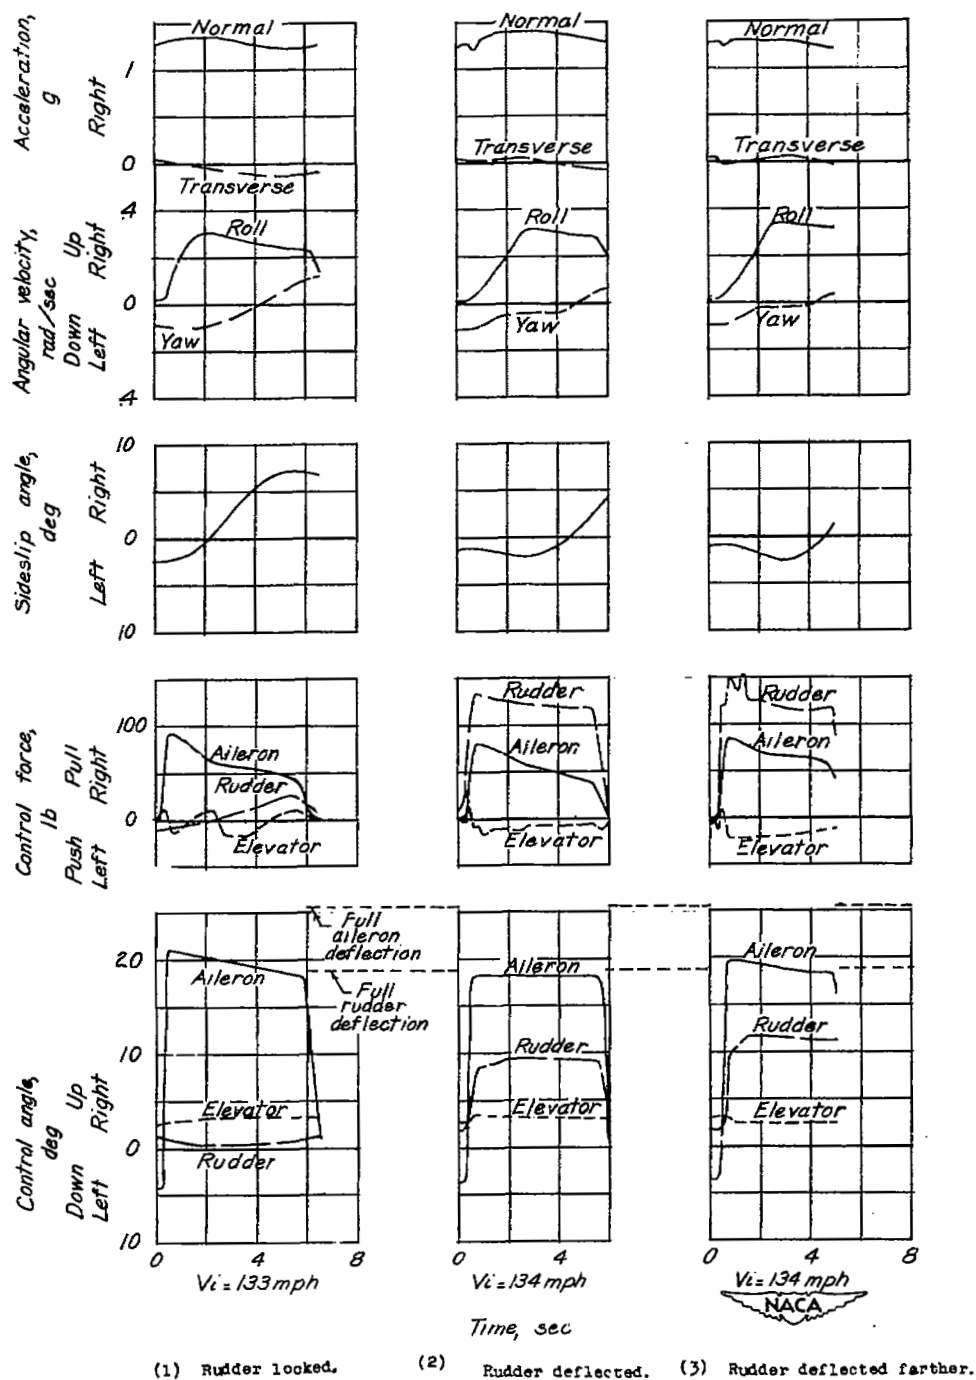
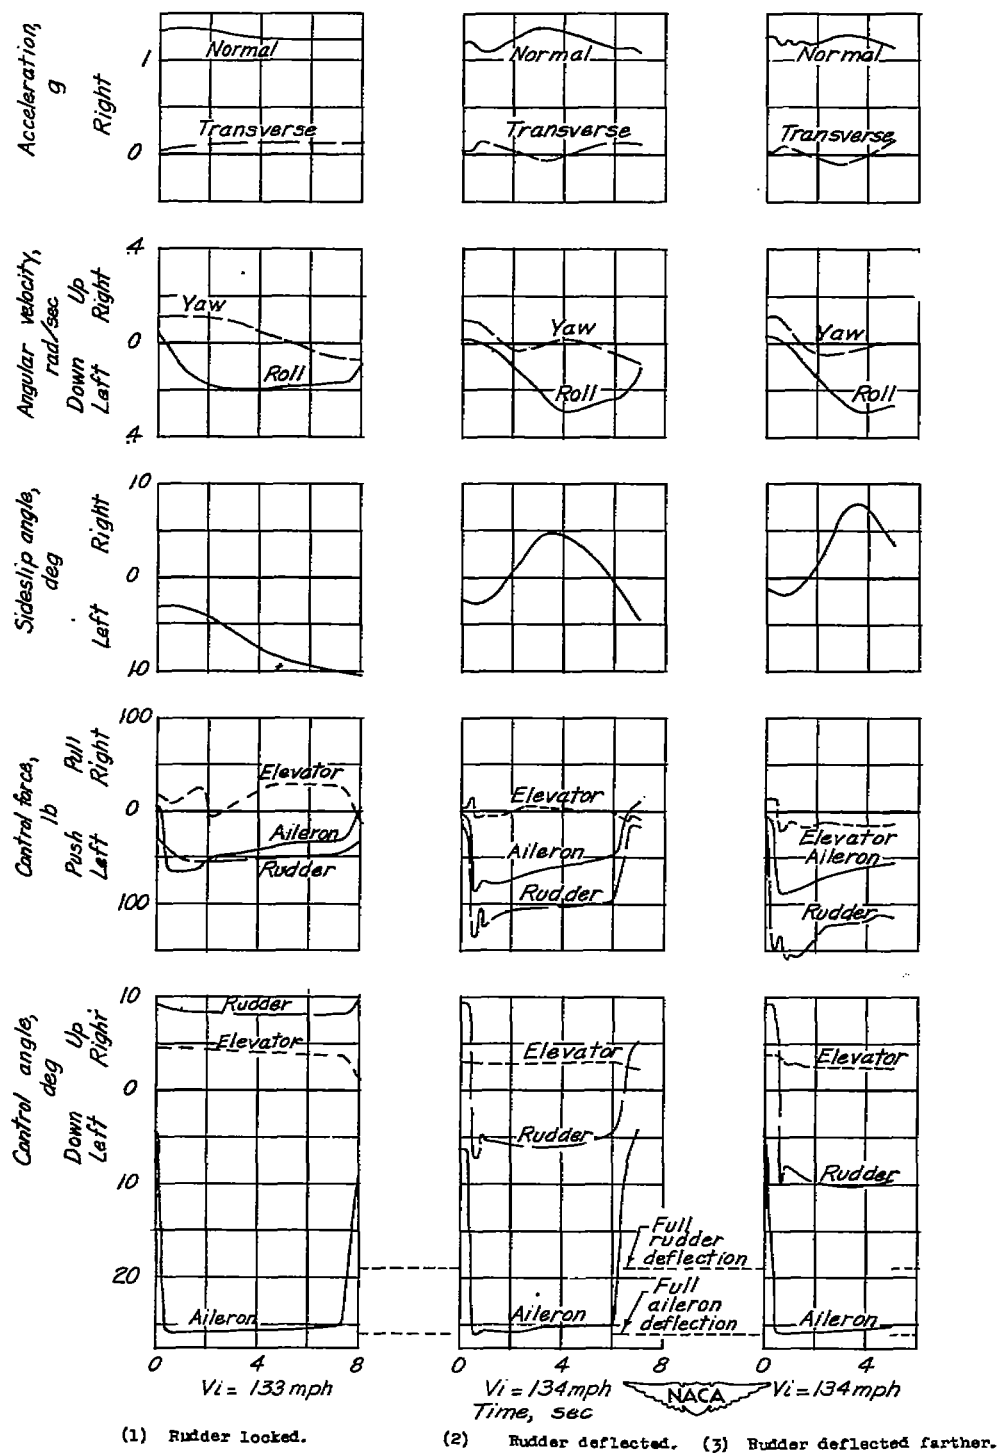
Figure 8.— Time histories of rolls out of 45° banked turns. Flaps down; gear down; power for level flight. C-54D airplane.
